HAWERA WATER TOWER RESTORATION

Craig Stevenson ¹ and Hugo Jackson ²

ABSTRACT

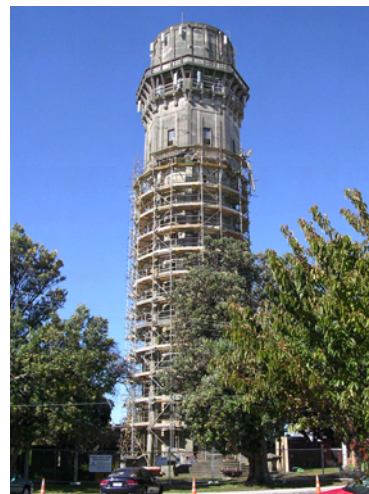
Figure 5: Scaffold erection

The scope of the work was such that full interior and exterior scaffolding of the tower was required. This was complicated by the tower's circular cross section, the stairs at the base and the profile of the tower which bells at the top. Component systems did not have the required flexibility and a tube and clip system was erected. This was then covered with a double layer of scrim screening to provide some protection from the weather and to contain any construction debris. The 40m height meant that a specific design by Registered Engineer was required.

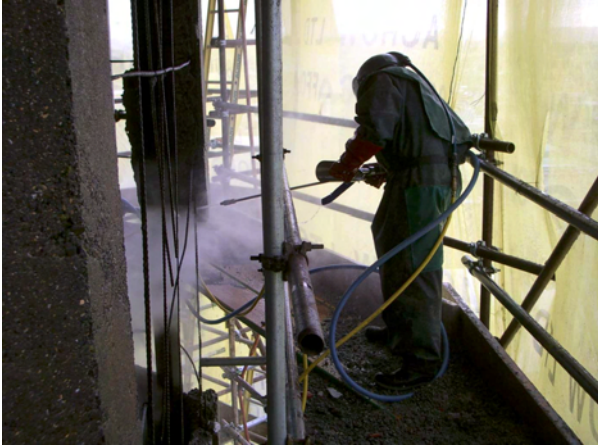
Figure 6: Hydro demolition of degraded concrete

The contract was let on the basis of an estimated volume of concrete to be removed and reinstated. However, during the hydro-demolition process it was found that the volume of degraded concrete requiring removal was twice the original estimated volume.

Deteriorated concrete was removed by hydro demolition. With this process extremely high pressure water jetting erodes the concrete.

Operating pressures are 6 to 7 times higher than conventional water blasters. This process is less likely to further propagate cracking than conventional jack hammering and has the added advantage of producing an excellent profile to key reinstatement concrete.

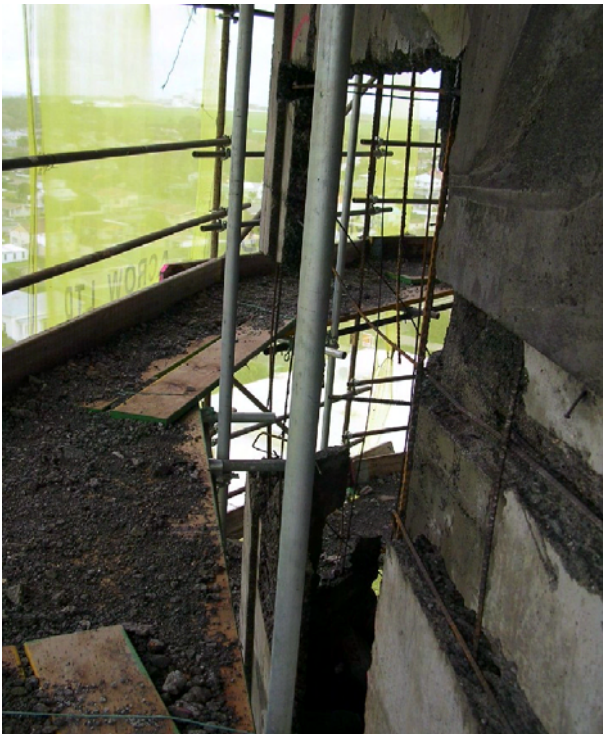
Figure 7: Facade panels after hydro demolition

Extreme deterioration had occurred on 2 of the 8 facade panels surrounding the lower water tank and early on in the contract a decision was made to remove these 2 panels entirely and re-pour them between forms, using techniques very similar to the original construction. A flowable, small aggregate, self compacting concrete was specifically formulated for this purpose. This was winched to the top of the tower in bags and mixed at this location.

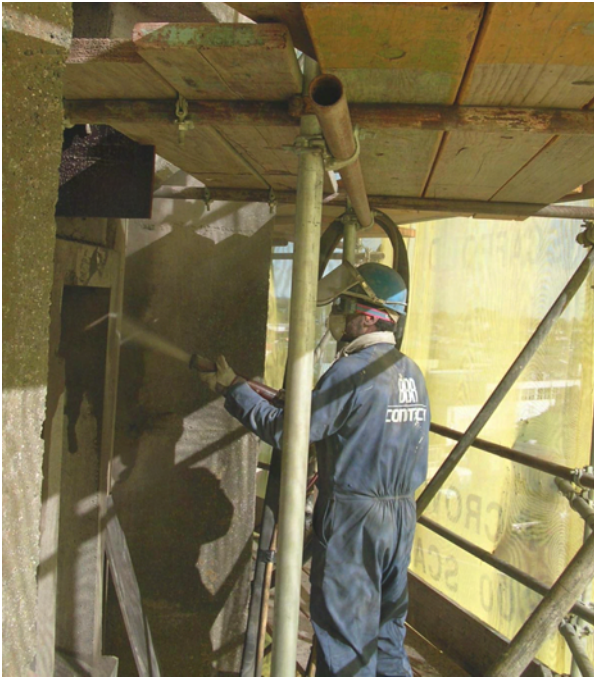
Figure 8: Guniting reinstatement of concrete

A number of processes were used to reinstate the removed concrete. The versatility and track record of a complete repair and protection system was very important. A variety of repair materials and techniques were proposed at the time of tender to cater for repairs of different sizes, orientation and form. The dry sprayed gunite process was used extensively and approximately 70% of the repair volume was reinstated using this method. It was possible to load the dry spray machine at ground level and convey the gunite to the top of the tower, for application. This removed the need to winch equipment and materials to the top of the tower for application by other processes.

Where the extent of repair to be reinstated neither extended to the full depth nor to the edge of a concrete member, gunite was sprayed directly into the void. Where the repairs extended through or to the edge of a member, gunite was sprayed against plywood back or side forms.

It was found that the best match to the weathered texture of the existing concrete could be achieved by scraping the fresh gunite with a steel float held perpendicular to the concrete surface.

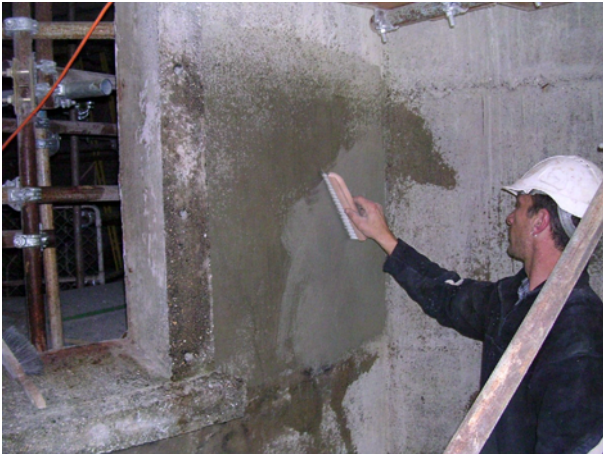
Figure 9: Application trial for cementitious coating

The application of a cementitious coating to all exterior surfaces followed the application of the migrating corrosion inhibitor.

This coating has a dual function of providing a water resistant barrier to further reduce the permeability of the concrete and also to give the tower a more uniform appearance to mask the contrast between the areas repaired and the extremely weathered existing concrete.

Application was by brush at the request of heritage Architects to ensure the texture of the underlying concrete and the cold joints from the original construction were not obscured.
